EcoSpect, Inc.

XRF Survey for Lead

RE: Private Residence

XRF Test Results

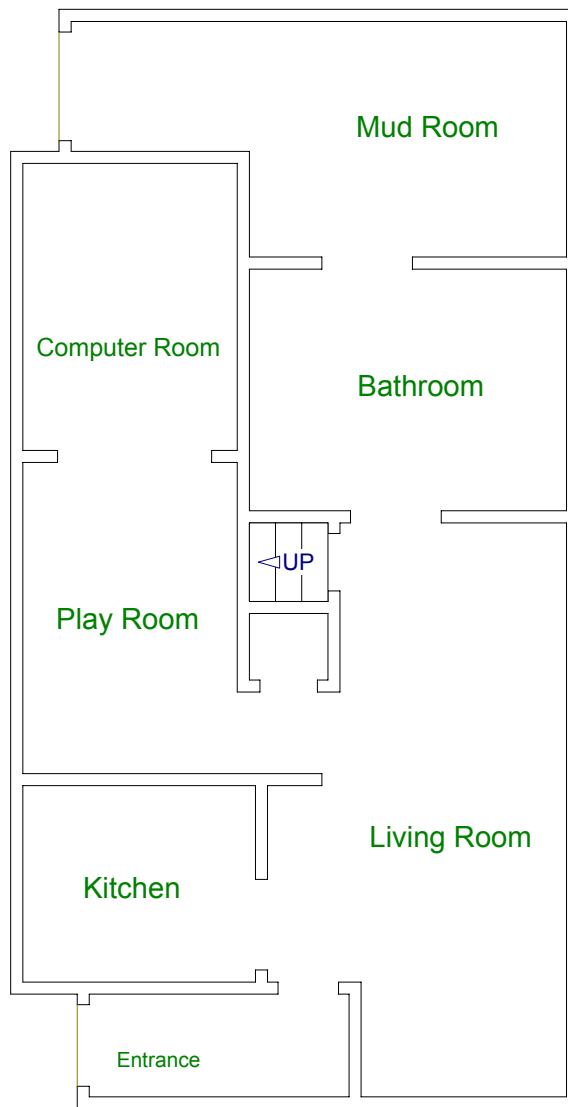
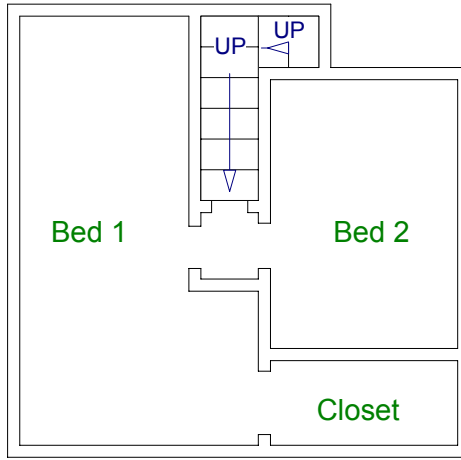
Drawing No To Scale

Wall #3

Wall #2

Wall #4

Wall #1

A report identifying the areas tested and the test results follow this letter. The walls in each space were oriented in a clockwise fashion, with wall #1 oriented to the front of the residence on Hazelhurst St. Please refer to the floor plan, not drawn to scale, for locations of the components tested.
